INDOOR AIR QUALITY ASSESSMENT

**Hull School Administration Building
7 Hadassah Way
Hull, Massachusetts**

Prepared by:
Massachusetts Department of Public Health
Bureau of Environmental Health Assessment
Emergency Response/Indoor Air Quality Program
January 2004

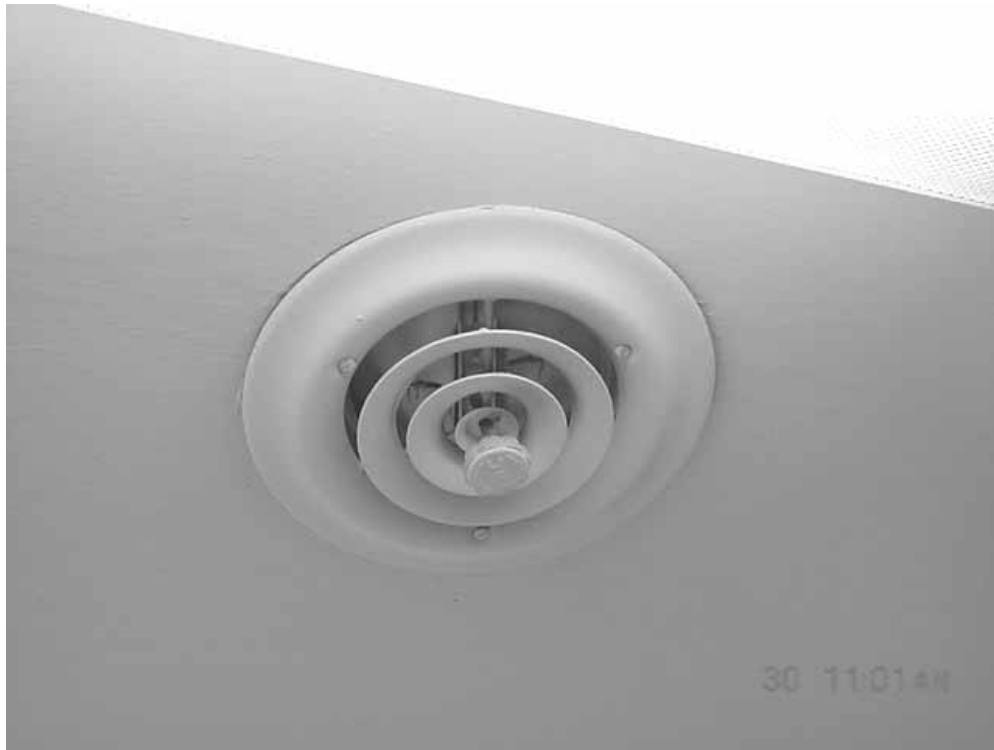
Picture 1

It can be seen from Table 1 that carbon dioxide levels were above 800 parts per million of air (ppm) in four of fourteen areas surveyed, indicating adequate ventilation in most areas of the building. Mechanical ventilation is reportedly provided by an air-handling unit (AHU) located in the attic. Supply air is distributed via ductwork connected to ceiling mounted air diffusers (Picture 1). BEHA staff could not gain access to the AHU at the time of the assessment. Town/school officials could not confirm whether the AHU is capable of introducing fresh air. Exhaust/return ventilation is provided by wall-mounted grills that are ducted back to the AHU. Several of these vents were blocked by bookcases and file cabinets (Picture 2). In order for exhaust ventilation to function as designed, vents must remain free of obstructions.

Supply Air Diffuser

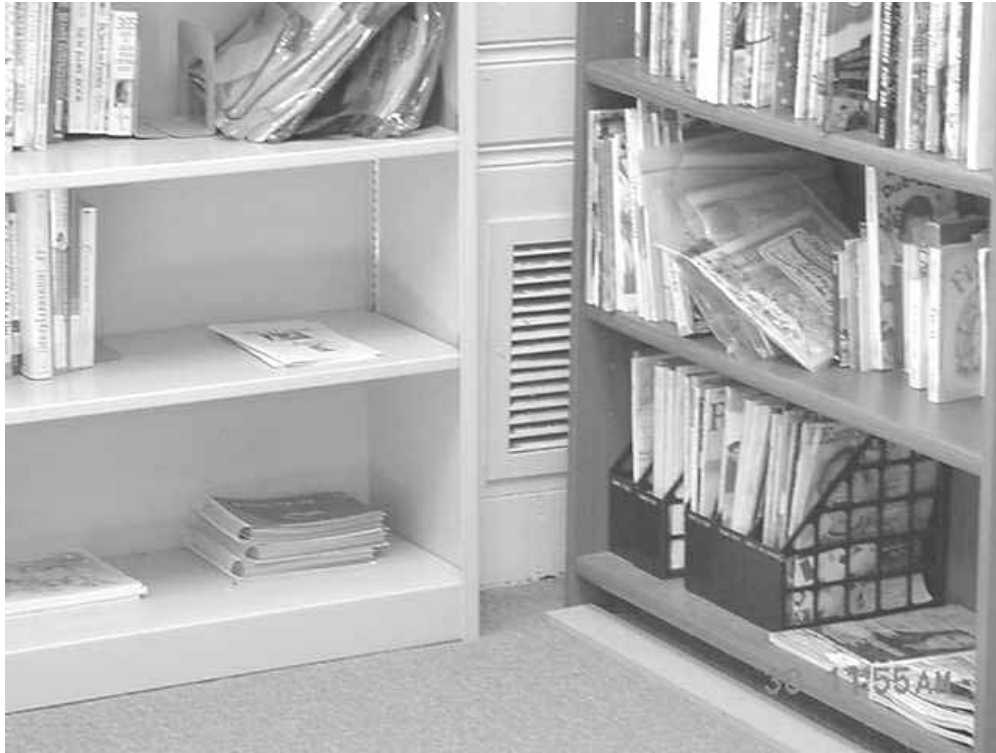
Picture 2

Exhaust/Return Vent Obstructed by Bookcase

4. Remove all blockages from exhaust/return vents to ensure adequate airflow.
5. Ventilation industrial standards recommend that mechanical ventilation systems be balanced every five years (SMACNA, 1994). Consult a ventilation engineer concerning re-balancing of the ventilation systems.

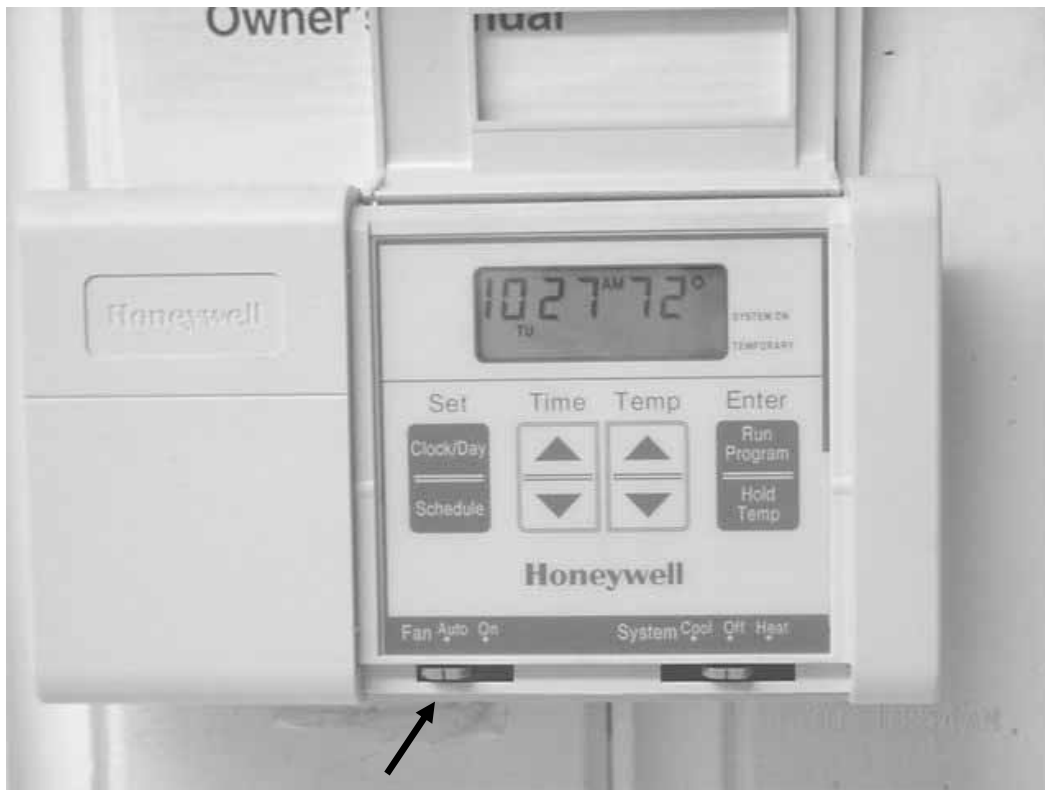
Picture 3

Thermostats control the ventilation system. These thermostats have fan settings of “on” and “automatic”. During the assessment, thermostats were set to the “automatic” setting (Picture 3). The automatic setting on the thermostat activates the system at a preset temperature. Once the thermostat reaches a preset temperature, the system is automatically deactivated.

Thermostat Fan Setting on “Auto”

To maximize air exchange, the BEHA recommends that both supply and exhaust ventilation operate continuously during periods of occupancy. In order to have proper ventilation, the mechanical supply and exhaust systems must be balanced to provide an adequate amount of fresh air to the interior of a room, while removing stale air from the room. The date of the last system balancing was not available at the time of the assessment. It is recommended that existing ventilation systems be re-balanced every five years to ensure adequate air systems function (SMACNA, 1994).

2. Contact the School Department's ventilation contractor to determine whether the system introducing outside air.
3. Operate both supply and exhaust ventilation continuously during periods of building occupancy independent of thermostat control. Set thermostat to fan "on" setting.

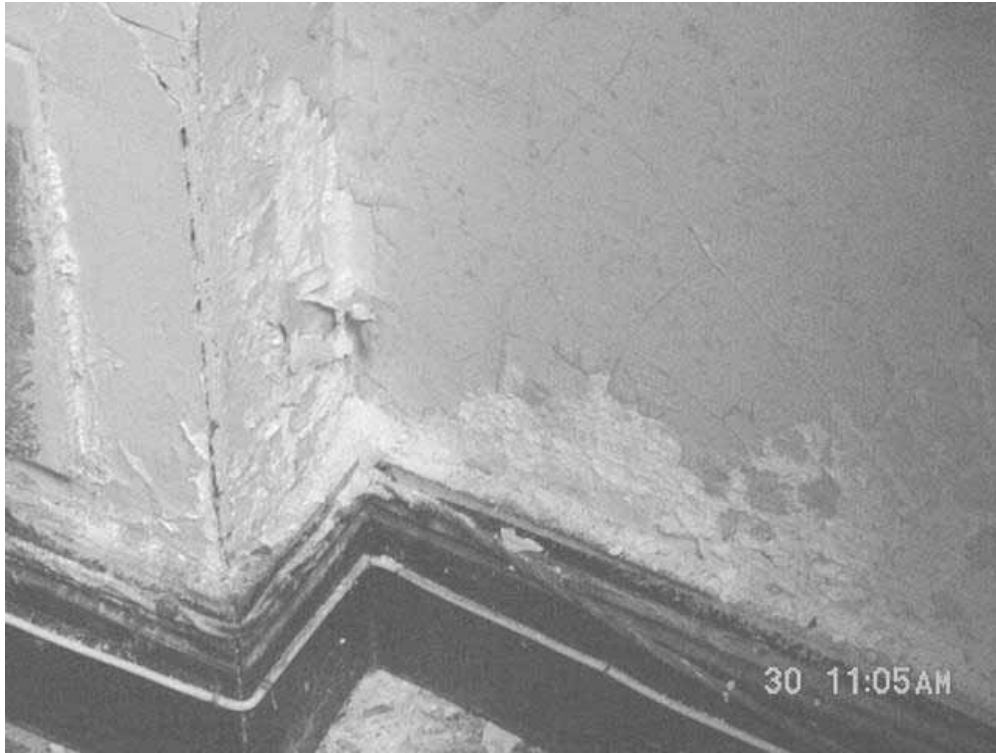
Picture 4

Water damaged wall plaster was noted in several rooms of the HSAB (Pictures 4 and 5). It is likely that this water damage is a result of water penetration through breaches in the building envelope (e.g., roof, exterior walls, door and window systems and foundation).

Water Damaged Wall Plaster and Efflorescence

8. Ensure all roof leaks are repaired. Examine the areas above water damaged ceilings for mold growth. Disinfect areas of water leaks with an appropriate antimicrobial.
9. Seal open utility holes and spaces on exterior of the building. Repair water damaged plaster on interior walls.
10. Refer to resource manuals and other related indoor air quality documents for further building-wide evaluations and advice on maintaining public buildings. These materials are located on the MDPH's website at <http://www.state.ma.us/dph/beha/iaq/iaqhome.htm>.

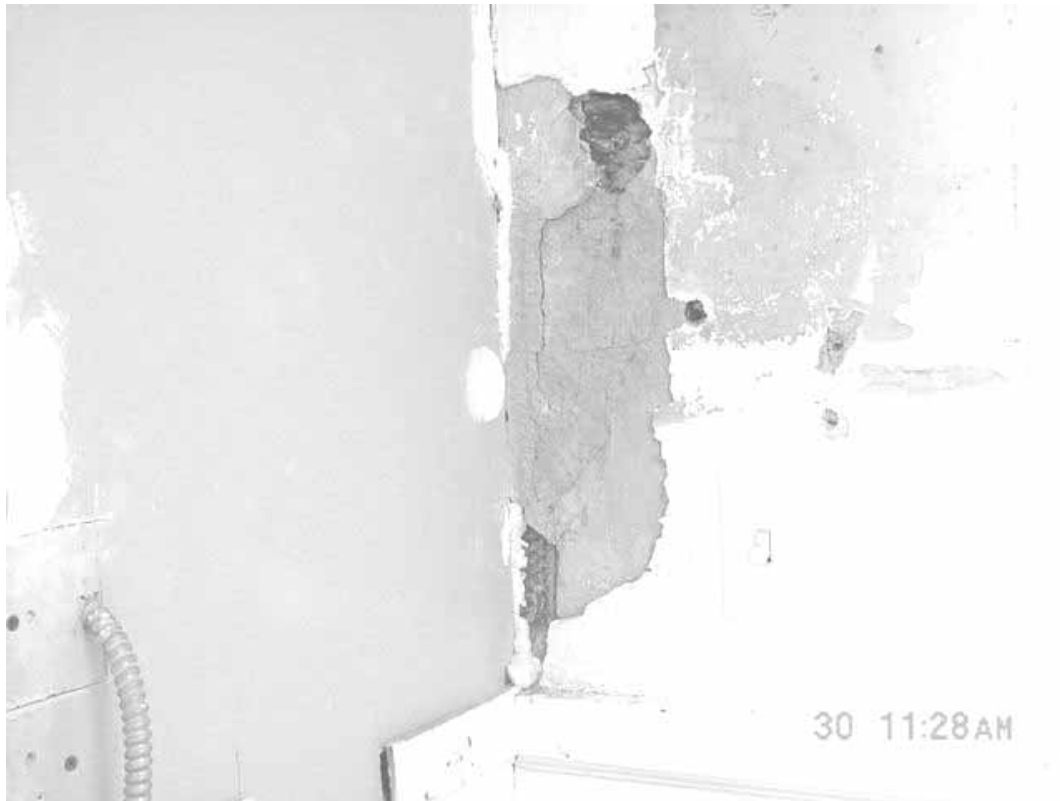
Picture 5

Water Damaged Wall Plaster

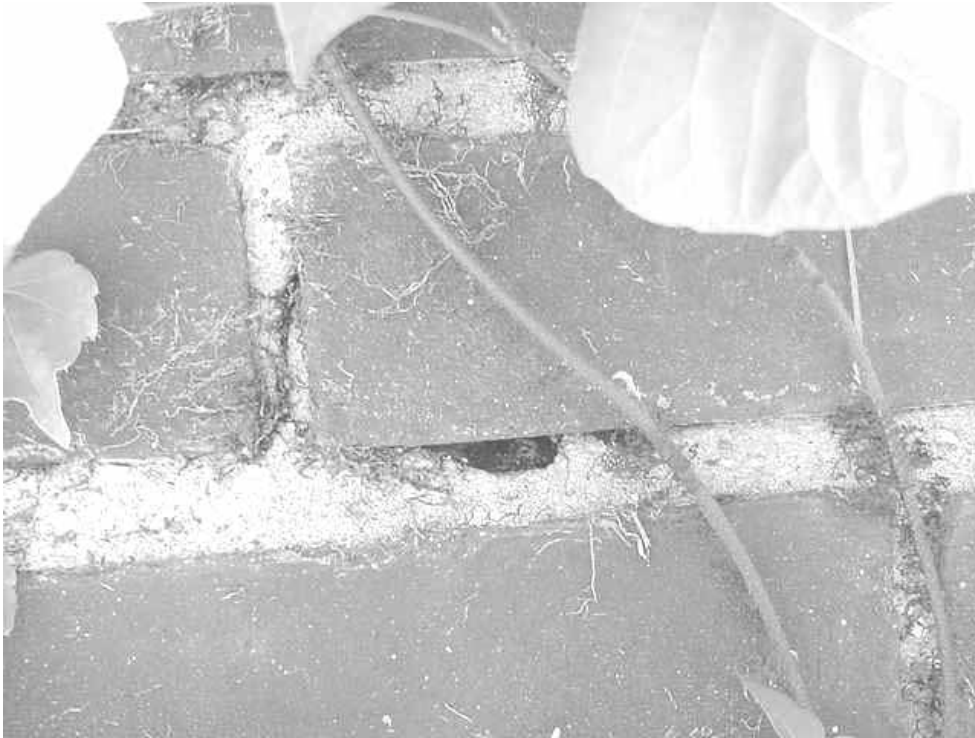
Picture 6

- Holes/spaces were observed on the exterior brick wall where mortar is missing/damaged (Pictures 6 and 7).
- Severely water-damaged wood exists along roof eaves and doorframes (Pictures 8 and 9).
- Spaces and missing/damaged caulking were observed around window frames in the building exterior (Picture 10).
- Roof edges are not equipped with a gutter/downspout system. Depending on wind and weather conditions, roof rainwater can run down the side of the building and penetrate through holes/spaces in the mortar or water can pool on the ground along the foundation.

Missing/Damaged Mortar around Brickwork

1. Consult with an architect and or general contractor regarding the integrity of the building envelope, primarily concerning water penetration through walls and around window frames. Examine the feasibility of repointing brickwork.
2. Consider installing gutters/downspouts to direct rainwater away from the building.
3. Consider repairing/replacing damaged wooden window/door frames to prevent water penetration.

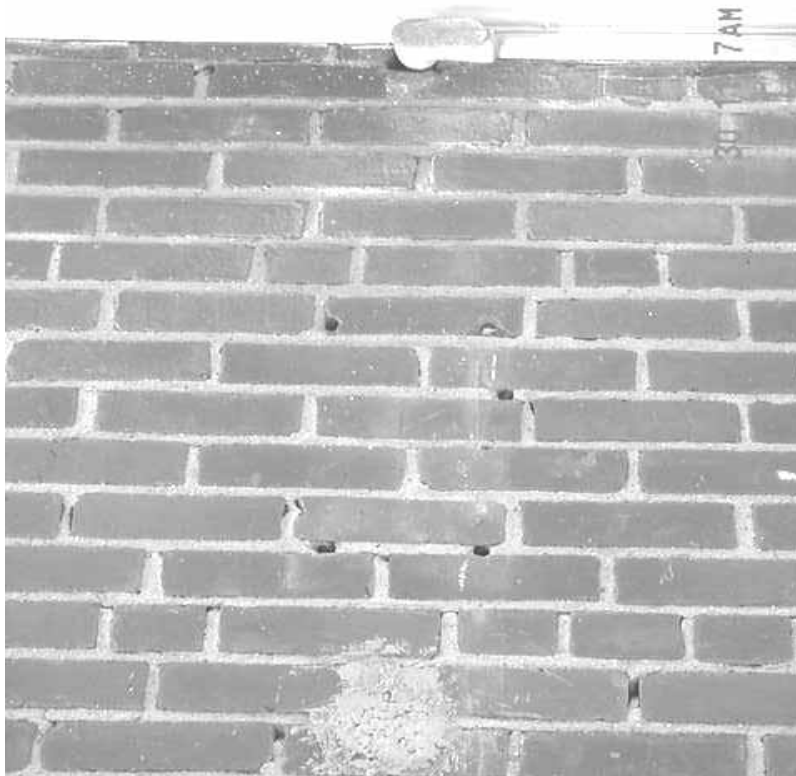
Picture 7

Holes and Missing/Damaged Mortar around Brickwork

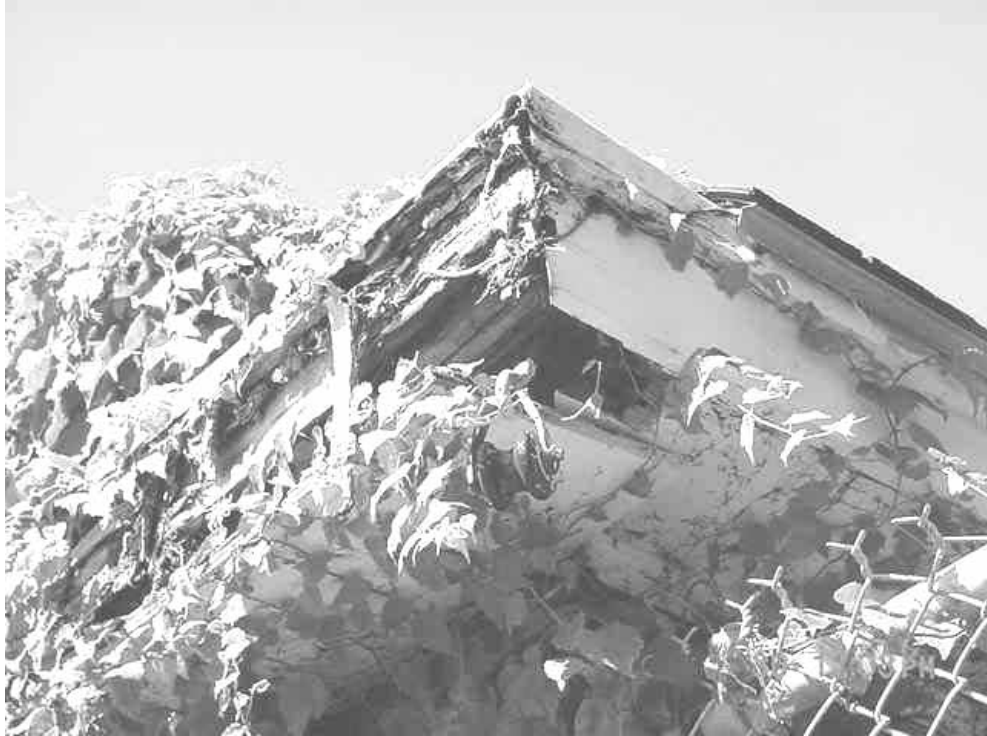
Picture 8

Rotted/Damaged Wood along Roof Eave

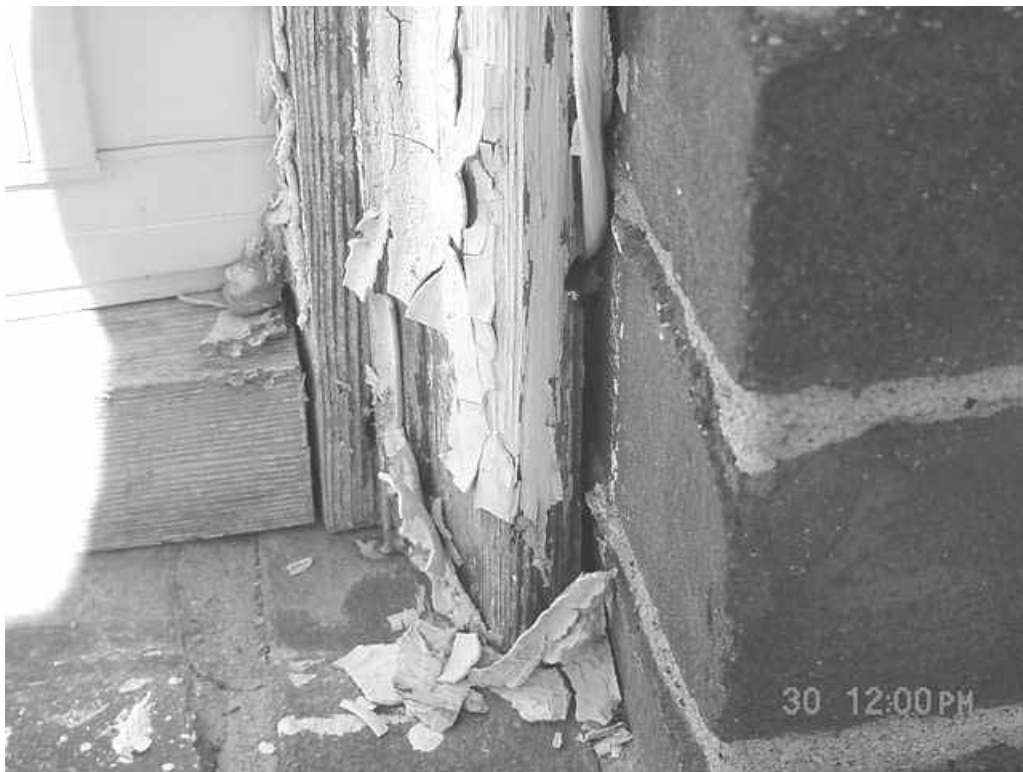
Picture 9

Damaged Wooden Door Frame

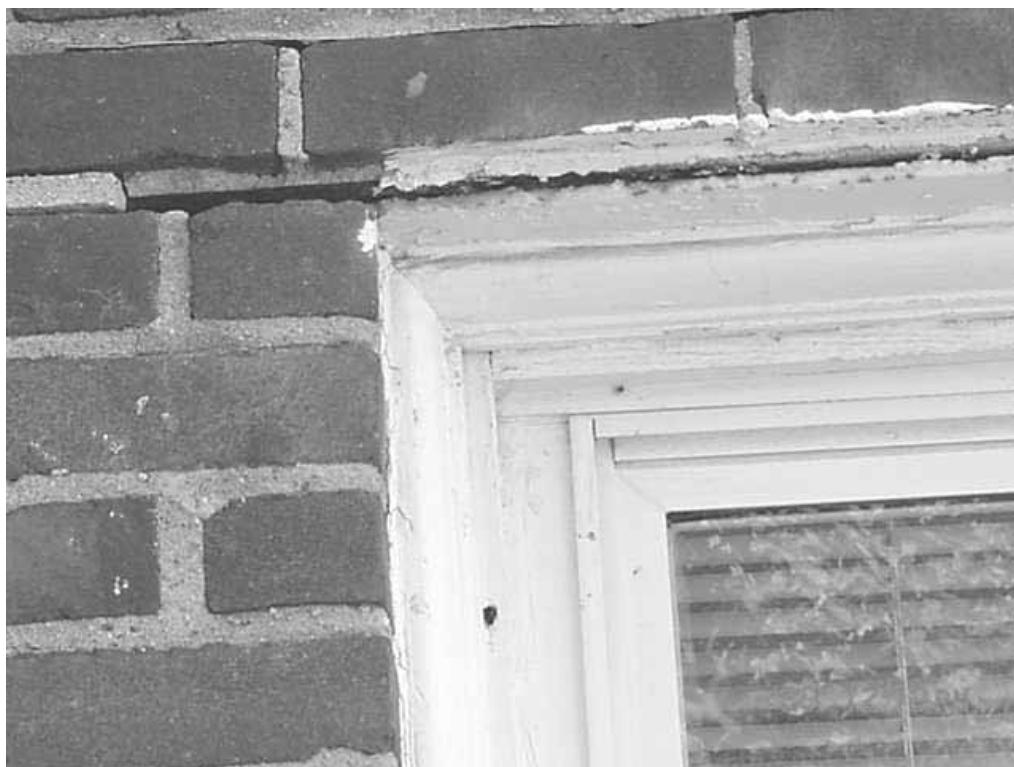
Picture 10

Spaces around Window Frames

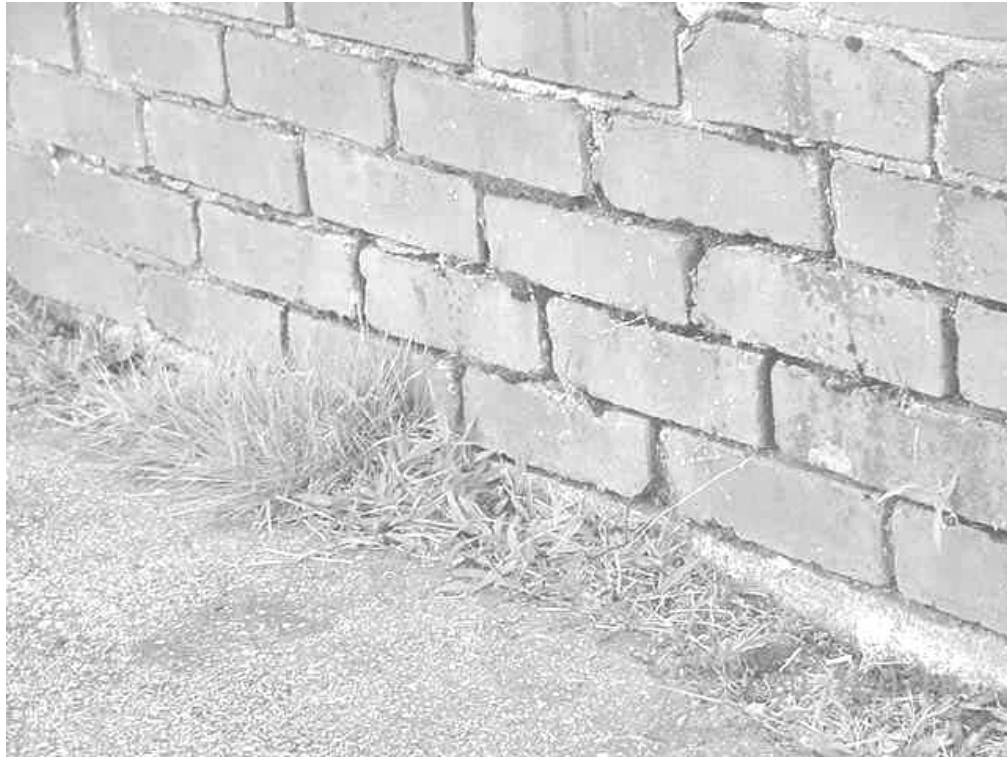
Picture 11

During winter weather, the freezing and thawing of moisture in bricks can accelerate the deterioration of brickwork. Growth of moss on exterior brickwork (Picture 11) is also an indication of chronic wetting of building components. Moss growth can also damage building components, as it holds moisture against brickwork.

Moss Growth between Bricks along Perimeter of the Building

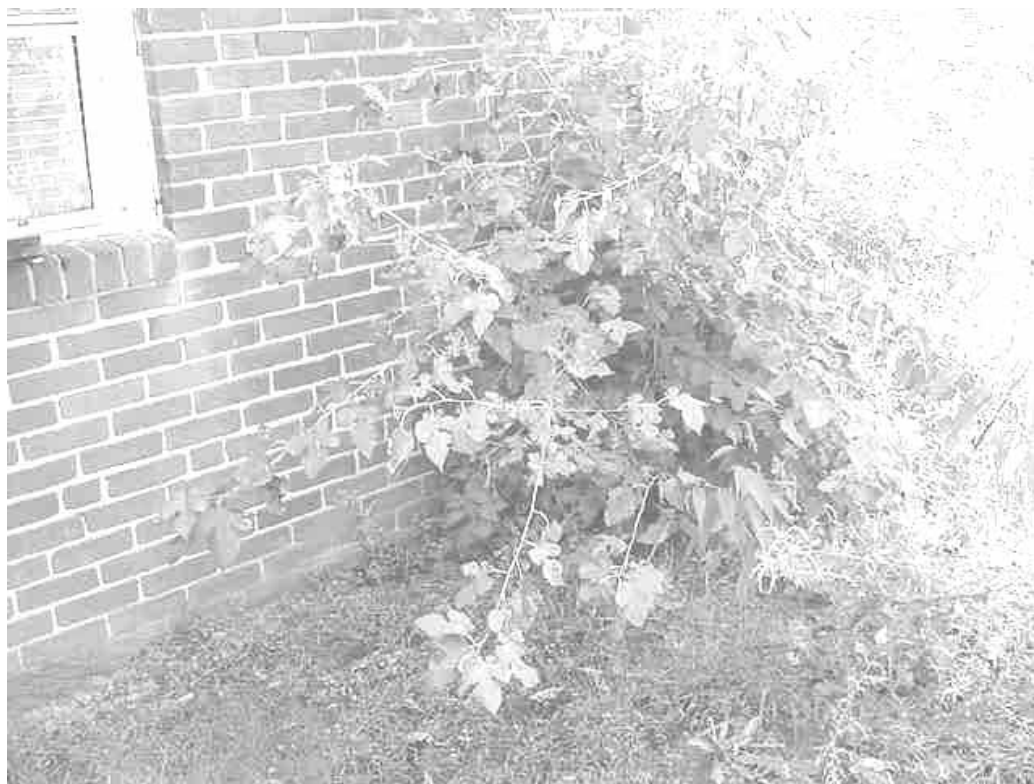
Picture 12

- Trees and other plants are growing against the building (Picture 12). The growth of roots against the exterior walls of a building can bring moisture in contact with building materials. The roots may eventually breach the building envelope, causing water damage and subsequent microbial growth. Ivy is also covering exterior walls. Clinging plants can cause water damage to brickwork through insertion of tendrils into brick and mortar.
- Water-stained ceiling plaster was seen in the hallway outside the superintendent's office, which is evidence of a roof or plumbing leak. As discussed, water-damaged building materials can provide a source for mold growth, especially if wetted repeatedly.

Plants/Trees Growth against Building

7. Remove plants or relocate approximately five feet away from the exterior wall of the building to prevent water impingement.
